EASHING STYLE COTTAGE: SU 946 436

by kind invitation of Mr and Mrs Tarring ; June 1981

Report by Joan Harding September 1981 Domestic Buildings Research Group (Surrey) 1981

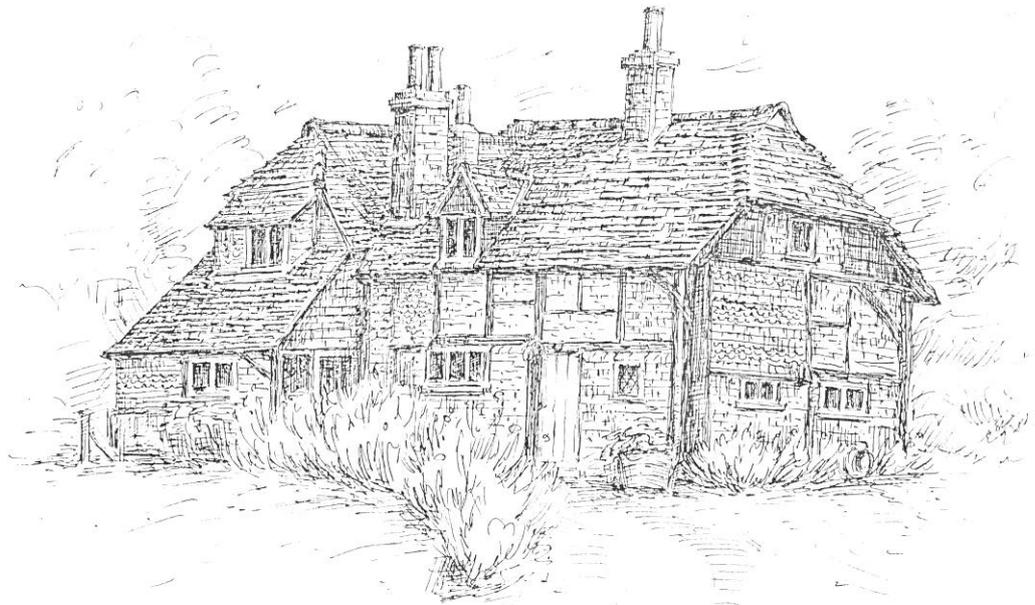
NORTH WEST SIDE

The detached cottage x-z has now been joined on.

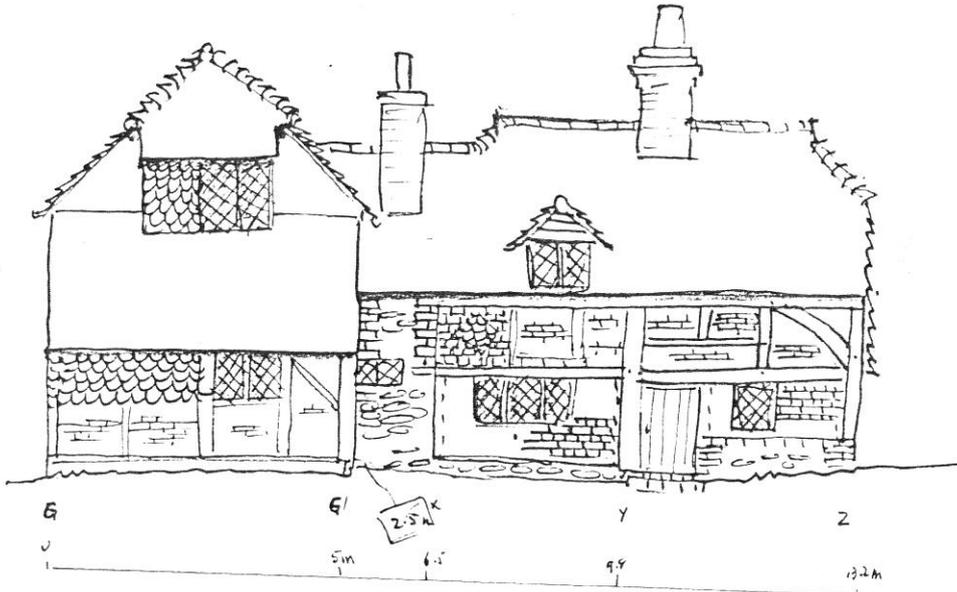
PROBABLE DEVELOPMENT

LARGE HOUSE

SMALL HOUSE
(should be at right angles)

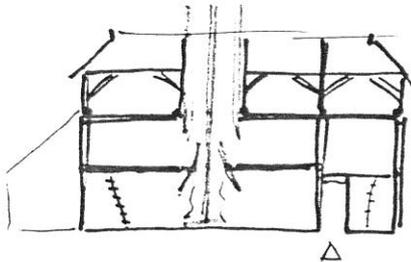
Early 17
Large house - brick chimney
small house - wattle & daub
hearth rooms

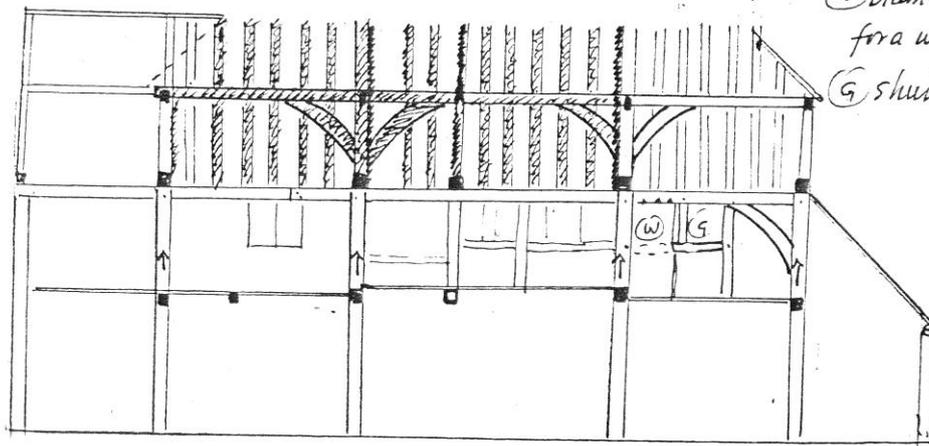
LONG DIAGRAM

IN ROOF
Rafters $11\frac{1}{2} \times 5 \times 38\text{mm}$
apls
scathed carpenter's
marks

ADDED
5 6 5

(W) Diamond mullion
for a wind hole
(G) shutter groove

The roof structure in both houses is clasped purlin with curved wind bracing. In both house the rafters are sooted over the open hall, as well as the deep sooting within the added smoke hood space.

There is a fine moulded spine beam in the larger house. Upstairs there is a shutter groove under the diamond mullion window.

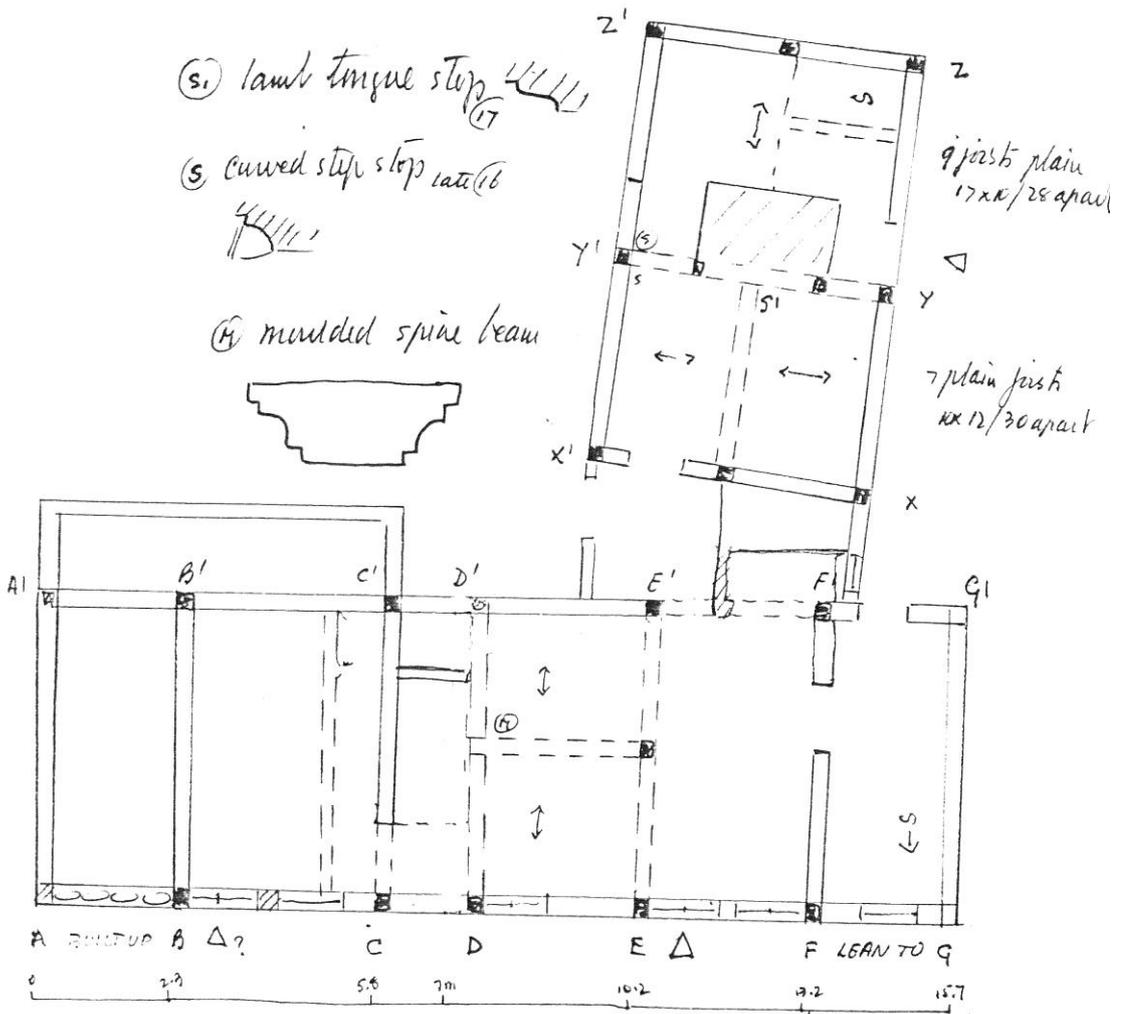
PLAN

○ WELL

(S) lamb tongue stop

(S) curved stop stop

(H) muddled spine beam

A B C D E F G
 0 2.2 5.6 7.0 10.2 12.2 15.7

An indication of development is found in the differing stops in the smaller house. Curved step stops (A) are found with smoke bays and smoke hoods. These come between circa 1550 and 1600. Lamb tongue stops (B) are found with chimney houses and on additions made then - 1666 on.

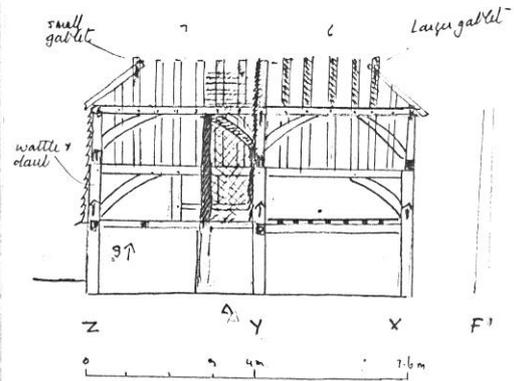
EXISTING WALL CENTER
Carpenter's assembly marks

There are carpenter's assembly marks, long and branching which are appropriate for a house with good scantling timbers and heavy jowl posts.
